**Site tour of  
Vermont Compost Company  
1996 Main Street  
Montpelier, VT  
October 20, 2011 (typos corrected 10/26/11)**

**W. Pennebaker**

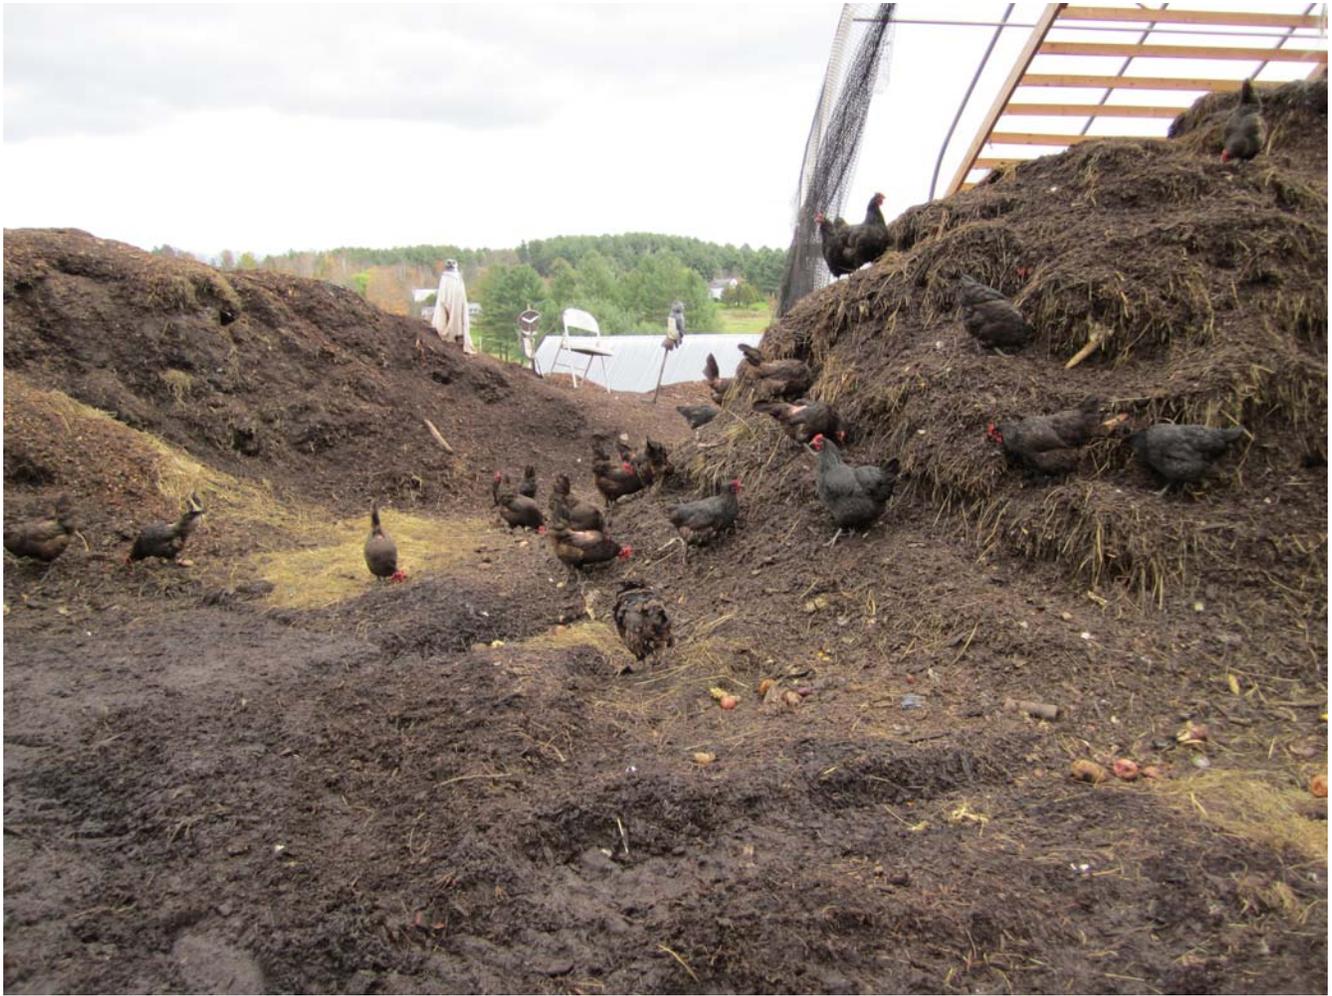
However, chickens apparently play an important role in formation of the compost, even though income the sale of eggs is minor. The chickens forage on the compost piles during the early stages of composting and therefore, in effect, process some of the food waste. According to Karl, chicken droppings are an important high-nutrient additive to the compost mixture. Even though some efforts have been made to minimize bird vectors, Karl actually views the presence of these “vectors” as an asset similar to chickens. Figure 1 shows the Vermont Compost Company chickens foraging in compost that had been processed for about two weeks (and thus, almost finished with the initial phase of composting).

*Figure 1: Chickens foraging on initial stage of compost.*

*Bird vectors have been addressed by adding metal frames (partially covered with plastic) over the two areas where initial composting is done (see figure 1). Only at this initial stage are food scraps likely to reach the surface of the compost where birds might get at them. Note the fake owls in figure 1 that help to scare wild birds away. Karl, incidentally, was quite skeptical of the mono-filament grid used to control bird vectors at the Williston facility.*

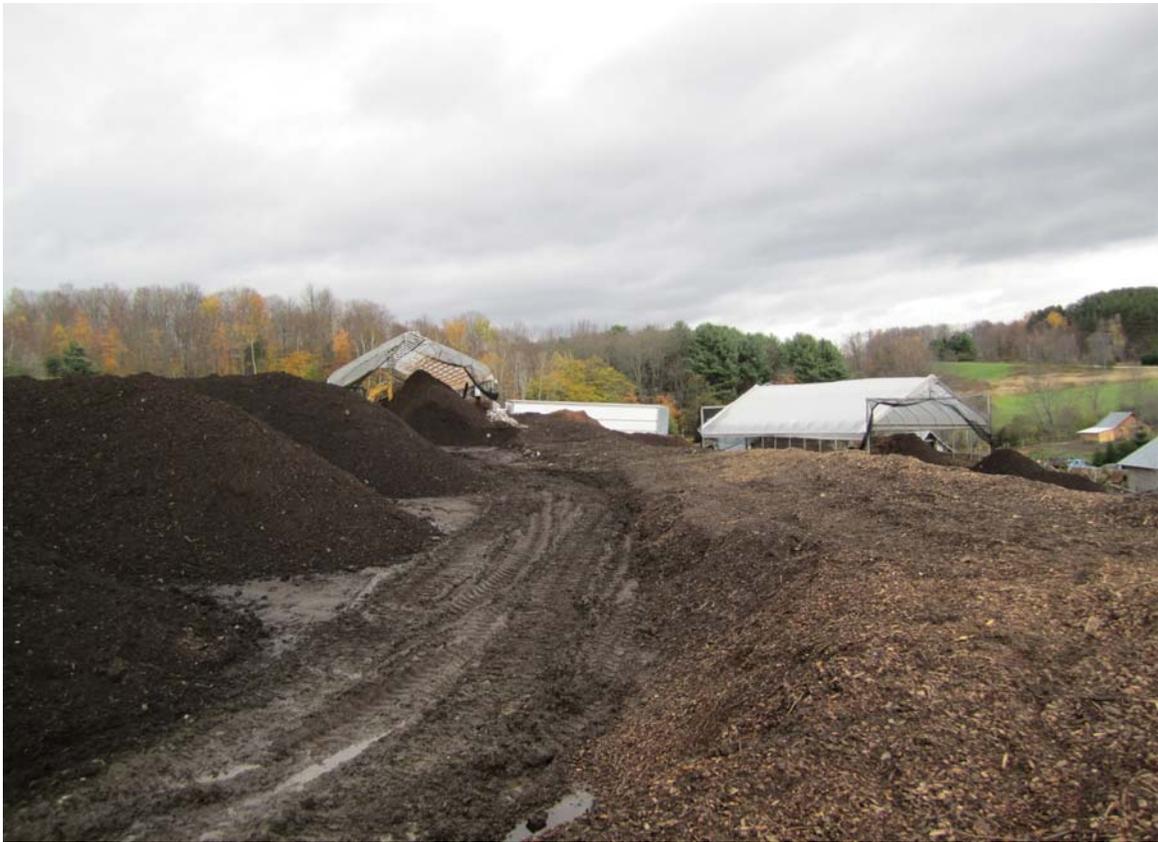
The actual composting is carried out further up the hill. The pitch of the hill is relatively steep and only at the back edge of the composting operations does the slope become more moderate. The first couple of weeks of composting are carried out in two metal frame sheds partially covered with plastic and located fairly close to the top of the steeply pitched section of the hill (see figure 2). Karl told me that the base under these areas is native soil, but the low permeability of the soil at the site and blockage of soil pores by organic matter means that little runoff from the compost reaches ground water. It appears to this observer, however, that leachate from the compost is controlled more by accident than design. The berm to the right in figure 2 is made of top soil from the site, compost and wood chips, and is periodically harvested.

*Figure 2: Plastic-covered metal frames covering initial compost stage.*

The metal frames covering the two initial composting stage areas can be seen in figure 2. Figure 3 shows the sheds where final processing and shipping are carried out. In the foreground of figure 3, just behind the sheds, are plastic-wrapped compost packages received from Fairmont Farms. Most of the area in figure 3 is in the 2+ acres covered by the Act 250 permit.

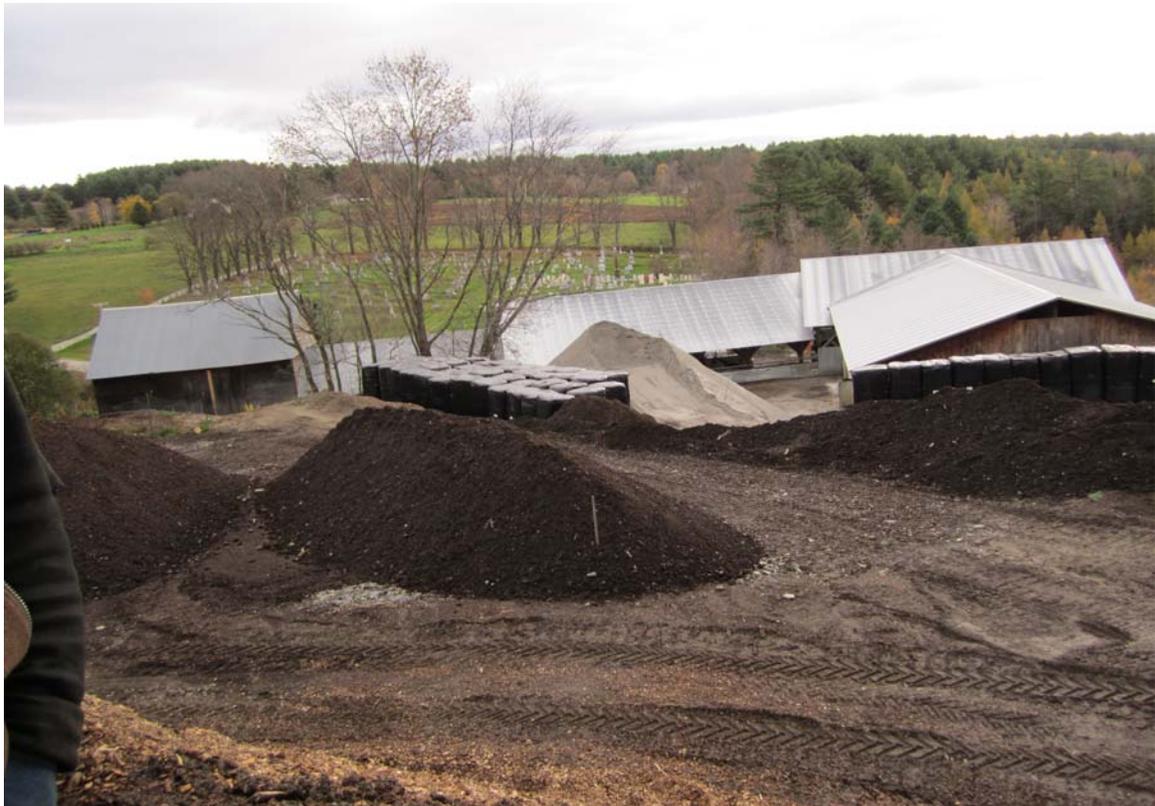
*Figure 3: Rear view of sheds for final processing and shipping*
